NMPSIA
Espanola Public Schools
Mountain View Elementary School

Loss Control & Safety Audit

This report contains the findings of an independent Loss Control & Safety Audit of Mountain View Elementary School. The audit was conducted on February 3, 2014, on behalf of the Espanola Public Schools, and at the request of NMPSIA.

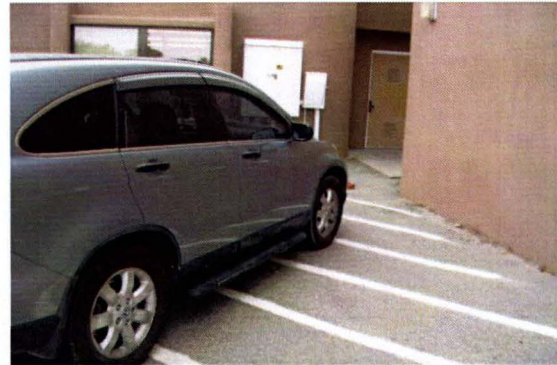
Recommendation Number: 2014-001

- Vehicles were parked in unauthorized parking areas and/or fire lanes.
- These practices pose property damage hazards and can delay or prevent proper emergency response.

- Parking locations should be marked and parking regulations should be observed at all times.

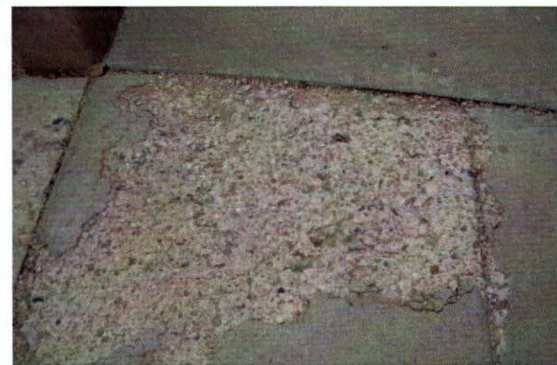
Recommendation Number: 2014-002

- Some of the paved areas had minor deterioration that, if left unrepaired, could worsen and result in trip/fall hazards.

- The pavement condition should be closely monitored and repairs made as needed.

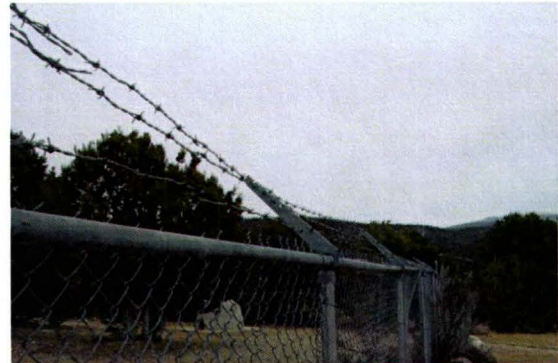
3. Is fencing provided, and are fences and gates of an appropriate type and condition?**Recommendation Number: 2014-003****Observations:**

- One or more fence sections were topped with razor and/or barbed wire.
- Razor and barbed wire pose injury hazards.

- The District should consider replacing the razor or barbed wire with a higher fence or a fence extension to prevent unauthorized entry.
- If the razor or barbed wire is retained, it should be inspected at least weekly to ensure it is kept in good condition.
- Inspections and repairs should be documented.
- Secured areas with high fences, fence extensions, or razor/barbed wire should be signed with appropriate warning signage to prevent trespassing.

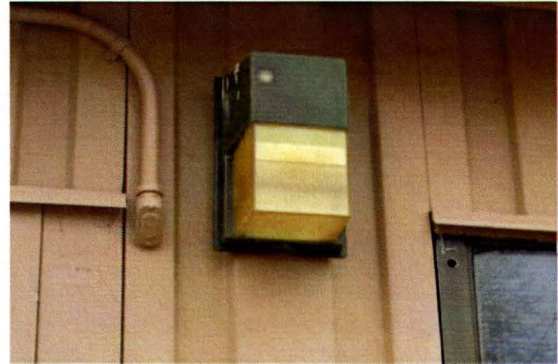
Recommendation Number: 2014-004

- An accumulation of dirt was visible in the diffusers for some of the overhead lights.
- Some of the light diffusers appeared to be yellowed.

- Dirty light fixtures should be cleaned so that illumination is not impaired.

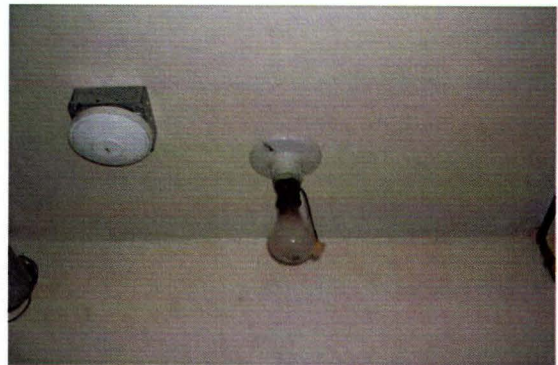
Recommendation Number: 2014-005

- Unprotected light fixtures were located in an area that may subject them to damage from contact with items being moved around the vicinity.

- All light bulbs located in areas where damage from collision is possible, such as the Custodial Closets and store rooms, should be fitted with protective wire cages.

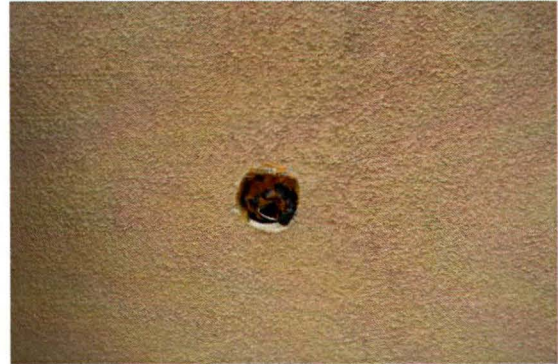
Recommendation Number: 2014-006

- The stucco exterior of one or more buildings was damaged.
- The damaged area exposes the building interior structure to the weather elements, and compromises the building's fire safety.

- The damaged areas should be repaired.

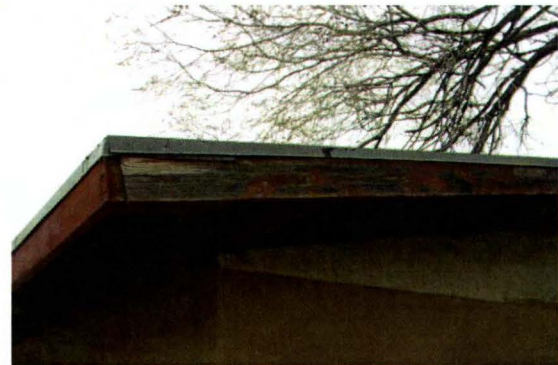
Recommendation Number: 2014-007

- The paint was peeling in some areas.
- The peeling paint can lead to accelerated building wear and poses an attractive nuisance.

- The peeling and flaking paint should be removed and the surfaces repainted to prevent accelerated building wear.

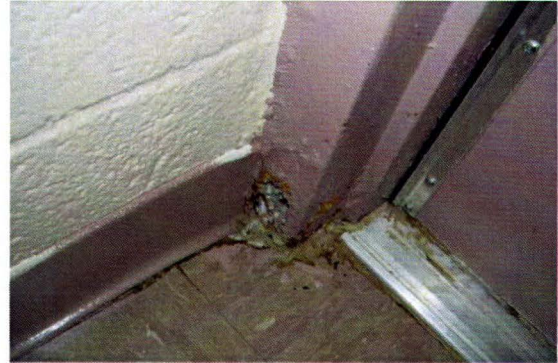
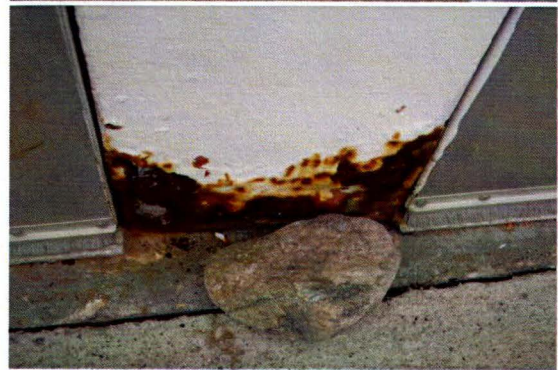
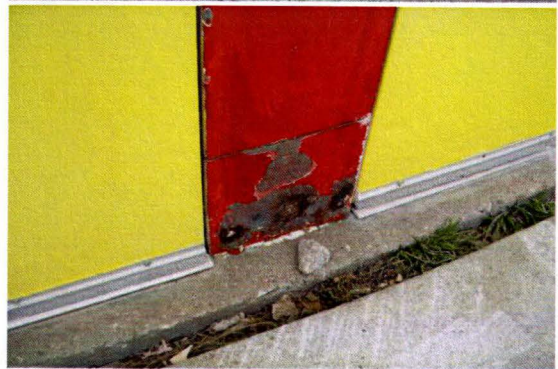
6. Do doors, windows, and glass appear to be of an appropriate type and condition?**Recommendation Number: 2014-008****Observations:**

- Door frames were rusting and deteriorated.

- The damaged door frames should be repaired and/or replaced.
- Door frames should be inspected, repaired and/or replaced on a regular basis to ensure that they function properly and provide adequate security.
- Any construction alterations should be designed and supervised by a person with expertise in building code requirements.

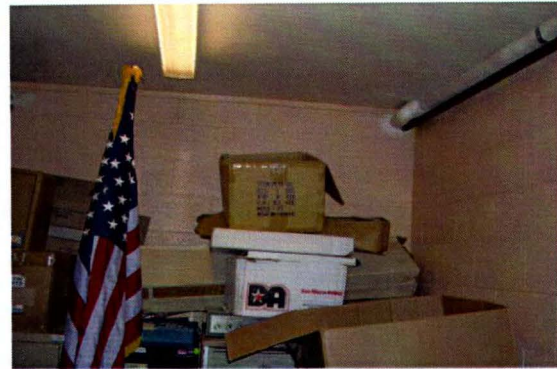
Recommendation Number: 2014-010

- The housekeeping needed improvement in some places.

- The area should be maintained in a neat and orderly manner, free from any condition that would create a fire or life hazard or a condition which would add to or contribute to the rapid spread of fire.
- All areas should be cleaned and organized to reduce injury and property damage hazards.

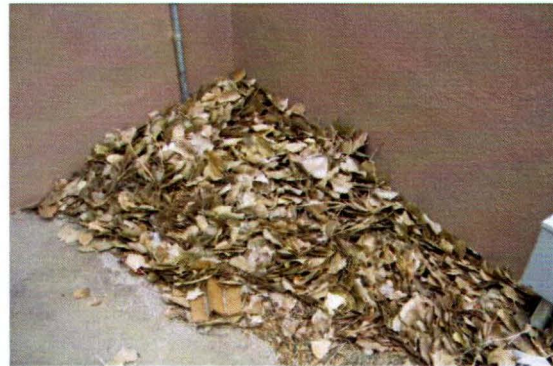
Recommendation Number: 2014-011

- Accumulated tree debris was present on sidewalks and/or in parking lots areas. This condition poses slip/fall hazards.
- Dry tree debris may present a fire hazard.
- Accumulated debris may also clog storm drains and/or gutters, which could lead to flooding or the improper drainage of water.

- The accumulation of tree debris should not be permitted on walkways, roadways, and/or parking lots.
- The District grounds department should review its schedule for removing tree debris.
- Consideration should be given to developing and implementing a tree debris control program, which may include replacement of debris-producing trees with other trees that produce less debris.

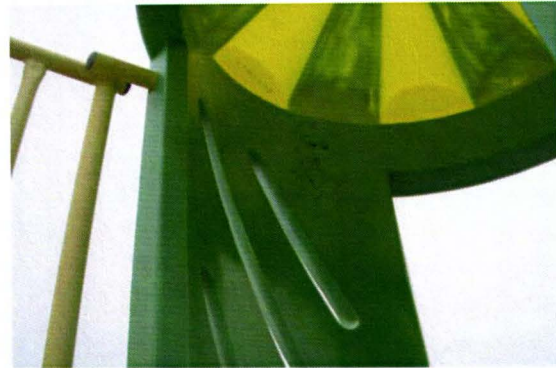
Recommendation Number: 2014-012

- Graffiti was present in some areas. The presence of graffiti invites additional graffiti.
- Prompt response to graffiti is a proven deterrent to future graffiti.

- Graffiti should be promptly covered or removed when discovered. Prior to removal, it should be photographed for documentation.

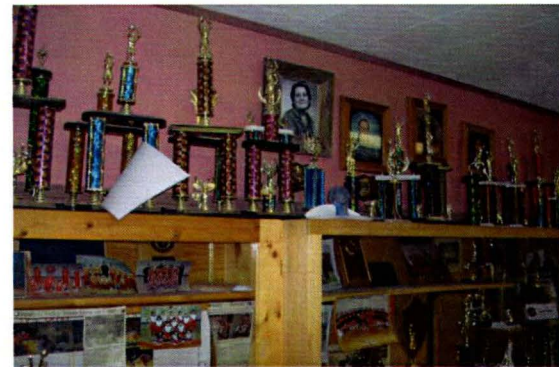
Recommendation Number: 2014-013

- Some of the trophies stored overhead were not secured.
- These unsecured items pose falling object hazards.

- Stored items should not create a hazard. Items should be shelved or racked in a manner designed to prevent them from tipping, falling, collapsing, rolling, or spreading.
- Racks, bins, planks, sleepers, bars, strips, blocks, and/or sheets should be used where necessary to make storage stable.
- Velcro, mounting putty, glue, or some other type of device should be used to secure large and/or heavy items stored overhead in public assembly areas and classrooms. Securing the items will prevent a falling object hazard during seismic activity. If the items cannot be secured, they should be removed.

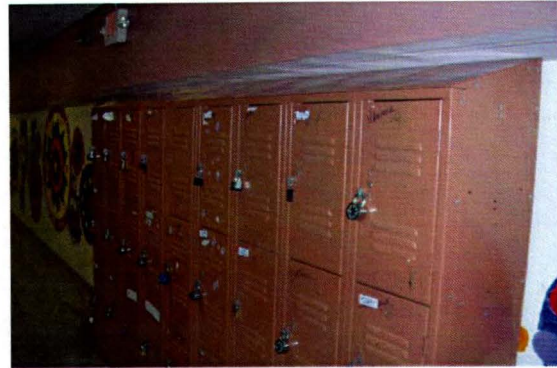
Recommendation Number: 2014-014**Observations:**

- Student lockers were present but not in use. Eliminating student lockers may reduce vandalism, contraband, and harassment incidents.

- Consideration should be given to removing the lockers.
- If the District chooses to retain the lockers, any damaged lockers should be repaired or replaced.
- If lockers are retained and used, they should be assigned by grade level to reduce the likelihood of harassment between grade levels.

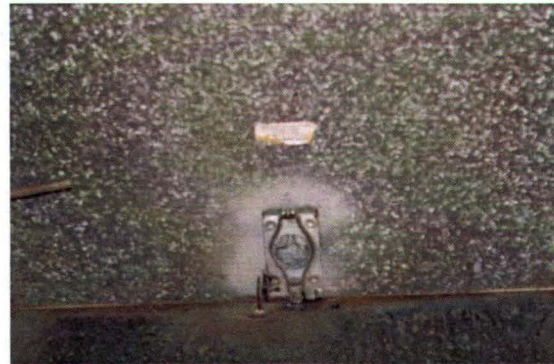
Recommendation Number: 2014-015**Observations:**

- The roof access panel was unlocked.
- The unlocked panel poses an attractive nuisance and compromises the security of the building.

- The roof access panel should be kept closed and locked.

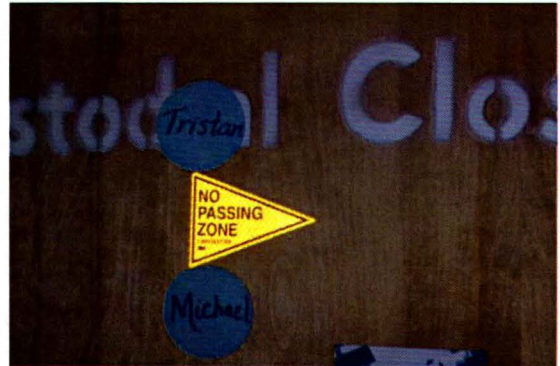
Recommendation Number: 2014-016**Observations:**

- Rooms that have roof access ladders were not properly signed. This could delay emergency response.

- Rooms that provide access to the roof should be conspicuously signed "ROOF ACCESS INSIDE" or something similar to alert emergency responders.

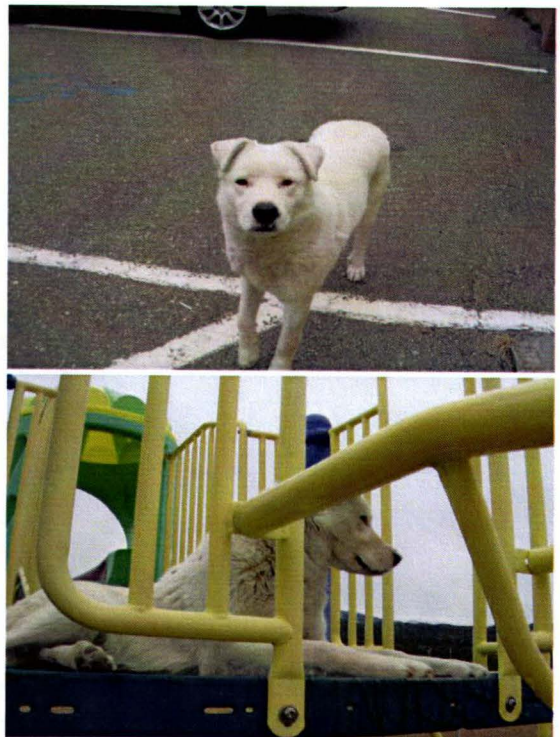
**Recommendation Number: 2014-017****Observations:**

- A dog was found on campus.

- Dogs other than working animals for the disabled should not be brought onto campus, except when in accordance with District regulations.

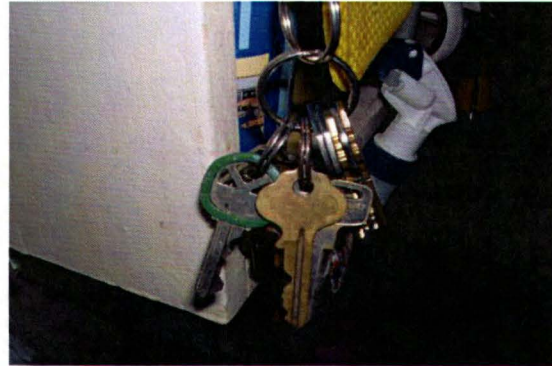
Recommendation Number: 2014-018**Observations:**

- Site keys were observed in an unlocked closet.
- This storage practice permits easy access to the keys and increases the risk of theft.

- A 'key locker' should be provided.
- The locker should be kept locked at all times.
- The removal of keys from the locker should be logged to identify who opened the locker, what keys were removed, to whom they were provided, the time and date of issue, and the time and date of return.

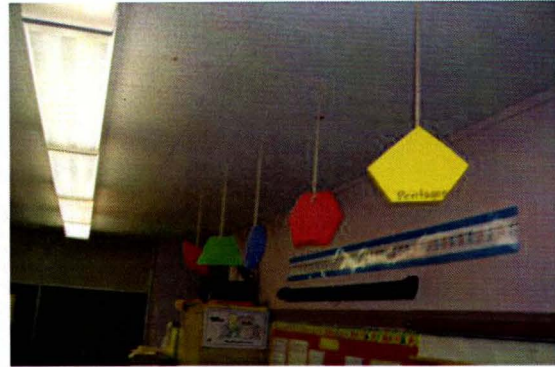
Recommendation Number: 2014-019

- Paper and/or other combustible materials were suspended from the ceilings or light fixtures. Suspending paper from ceilings can increase the spread of fire. Suspending paper from lights increases the fire hazard, as the lights are a potential ignition source.
- Hanging decorations may also trigger false alarms involving motion detection systems.

- Paper, string, and/or other artwork hanging from light fixtures should be removed. If artwork is suspended from the ceiling, it should be of minimal volume so as to not create an additional fire spread hazard and it should be maintained at least 80 inches or higher from the floor.

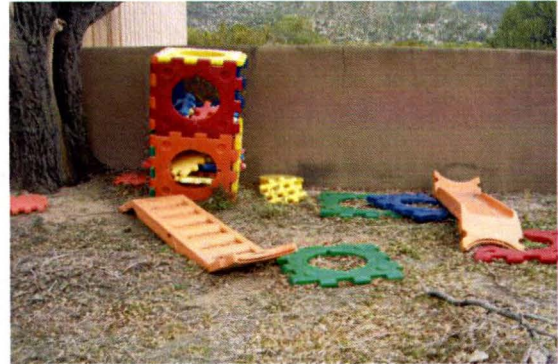
2. Are playground areas free of inappropriate, prohibited, or obsolete equipment?**Recommendation Number: 2014-021****Observations:**

- Residential-grade play structures were present on the playground. These types of structures are not designed or intended for use on public playgrounds.
- The equipment was not anchored in place; therefore, it could be tipped over or moved away from the protective surfacing and/or into the use zones of stationary play structures.
- Residential-grade play structures do not meet the materials and strength requirements for public playground equipment.
- Residential-grade play structure designs do not meet the requirements for public playgrounds as specified in ASTM International, Standard F-1487.

- All residential-grade play structures should be removed from the playground and disposed of. Their design hazards prohibit their use on public playgrounds.
- If it is uncertain whether a piece of equipment is designed or intended for use on public playgrounds, then the structure manufacturer should be contacted for this information. If the manufacturer indicates that the structure is designed and intended for use on public playgrounds, then the manufacturer should be requested to provide a written statement verifying this.

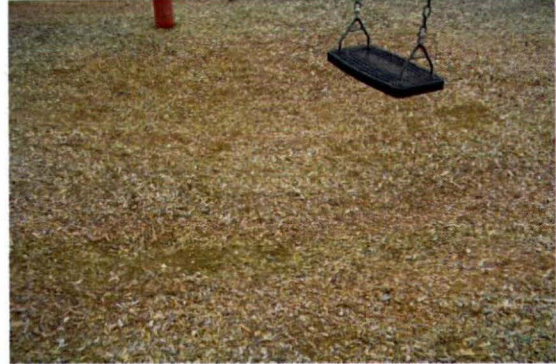
Recommendation Number: 2014-022

- The protective surfacing around and under the equipment was of an insufficient depth in some areas of the use zone and/or it did not extend throughout the entire use zone of the equipment.

- Protective surfacing should be installed and maintained throughout the entire use zone of the equipment being protected.
- The protective surfacing should be maintained in all areas of the equipment use zone so that it provides adequate protection for the maximum height of the equipment.
- The depth of the protective surfacing should be monitored and topped off as needed to ensure that it retains a fall height value equal to or greater than the fall height of the protected equipment.
